Little Mahanoy Creek Headwaters Watershed Restoration Plan

**Borough of Frackville, West Mahanoy, Butler and New Castle Townships
Mahanoy Watershed, Schuylkill County, Pennsylvania**

November 2, 2022

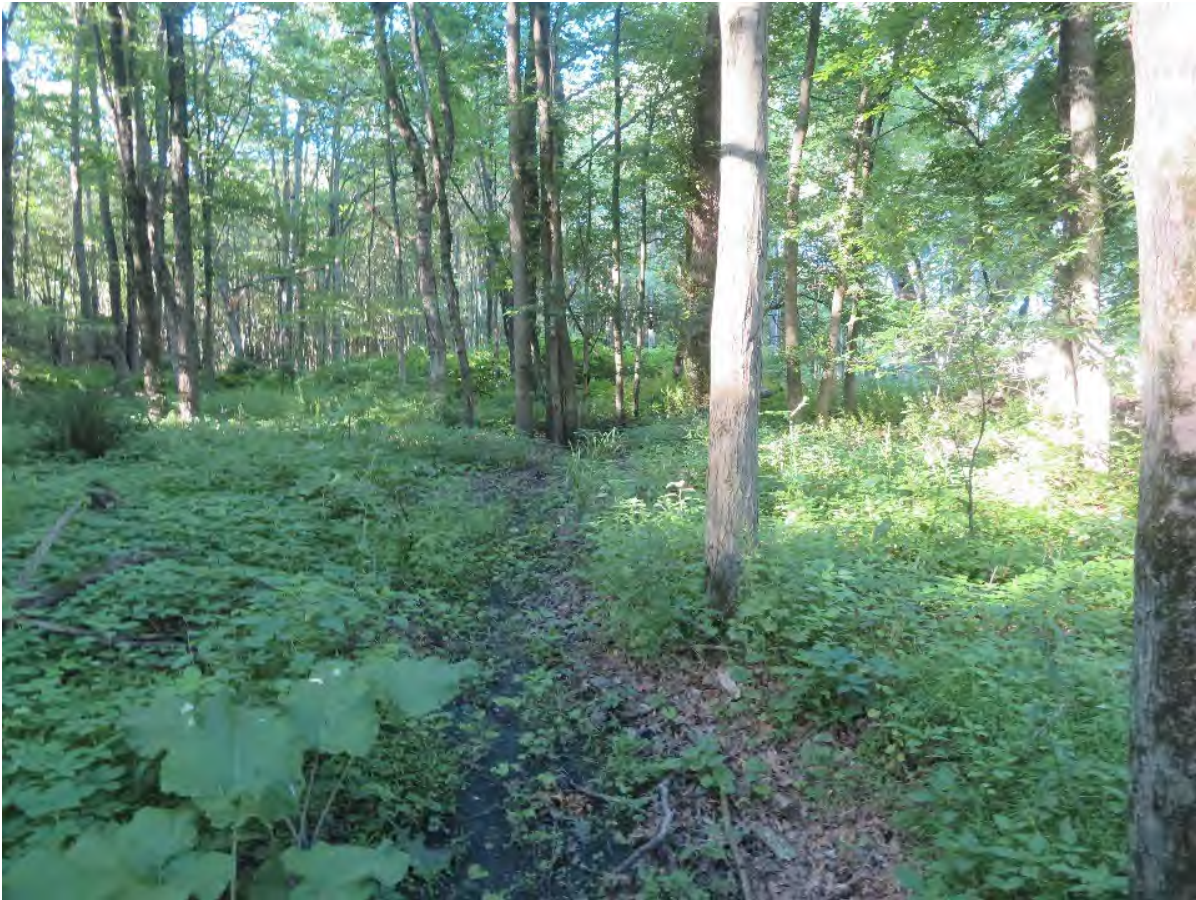
Impacted Stream Segment #1:

The area is overrun with invasive species including Japanese barberry (*Berberis thunbergii*), multiflora rose (*Rosa multiflora*), Japanese knotweed (*Reynoutria japonica*), garlic mustard (*Alliaria petiolata*) and packing grass (*Microstegium vimineum*). Mile-a-minute (*Persicaria perfoliata*) is an additional invasive species that is becoming established in the downstream portion of the study area. Invasive species dominate throughout the watershed. This high priority project applies to not only this area, but the entire watershed.

Restoration of the watershed should include the removal of invasive species. For each area where the invasives are removed, the need for planting of native species as replacements should be considered. Typically, removal of the invasive species within this watershed will include selective herbicide application on multiple occasions. Within the watershed as a whole, restoration projects should include a longterm maintenance plan that includes managing invasive species with an integrated pest management plan approach.

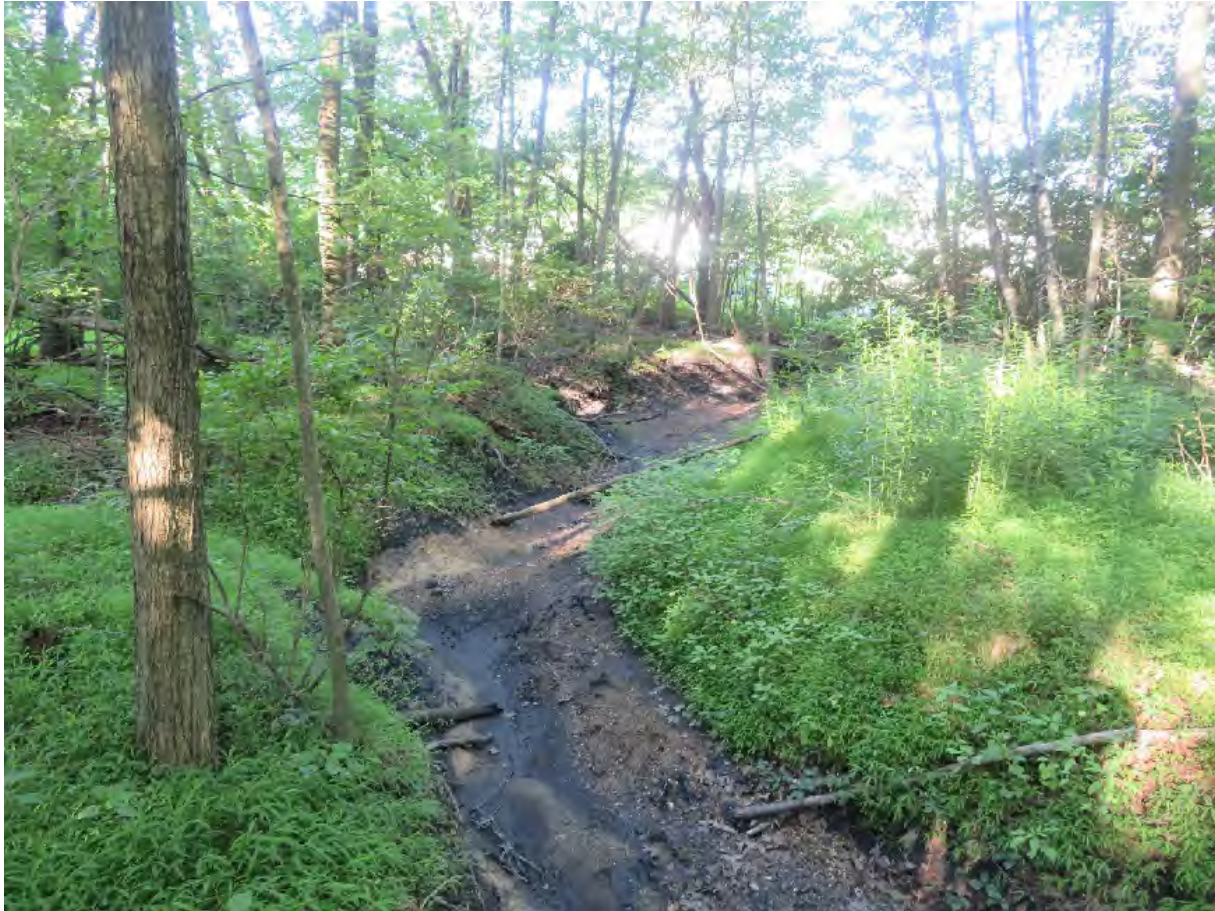
Impacted Stream Segment #1-3:

The headwaters of the Little Mahanoy consists of several intermittent channels located downstream of a recently reclaimed coal spoil pile. The stream enters into a stream enclosure taking the water under the road downstream of this segment. Within this stream segment, the stream channel is 2-4' deep and is actively eroding coal silt soils.

A stormwater bioretention area with constructed wetlands should be considered for the restoration of this area. Installation of the wetlands will require excavation and removal of the waste coal soils that are in this area. The hydrology from the intermittent stream channels should aid in the creation of sustainable wetland systems. In areas where the streams are not incorporated into the wetland cells, the streambanks should be graded to stable slopes. The constructed wetlands and restored streambanks should be replanted with native species.

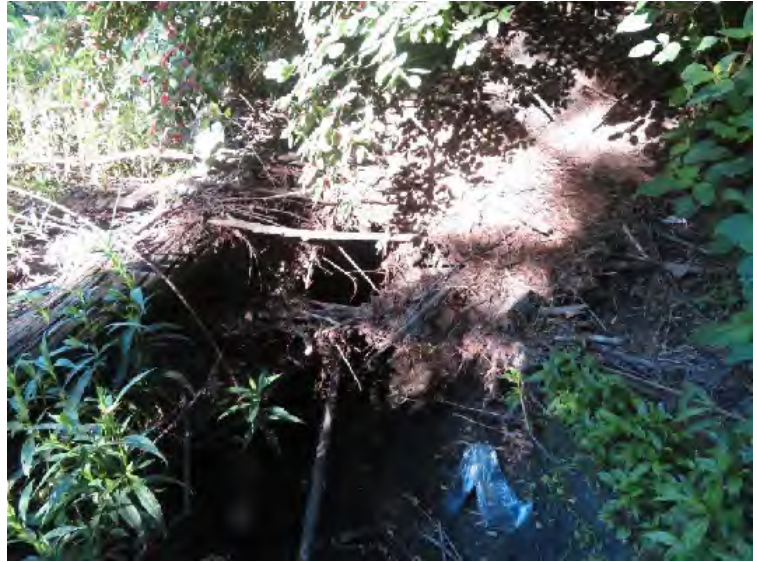
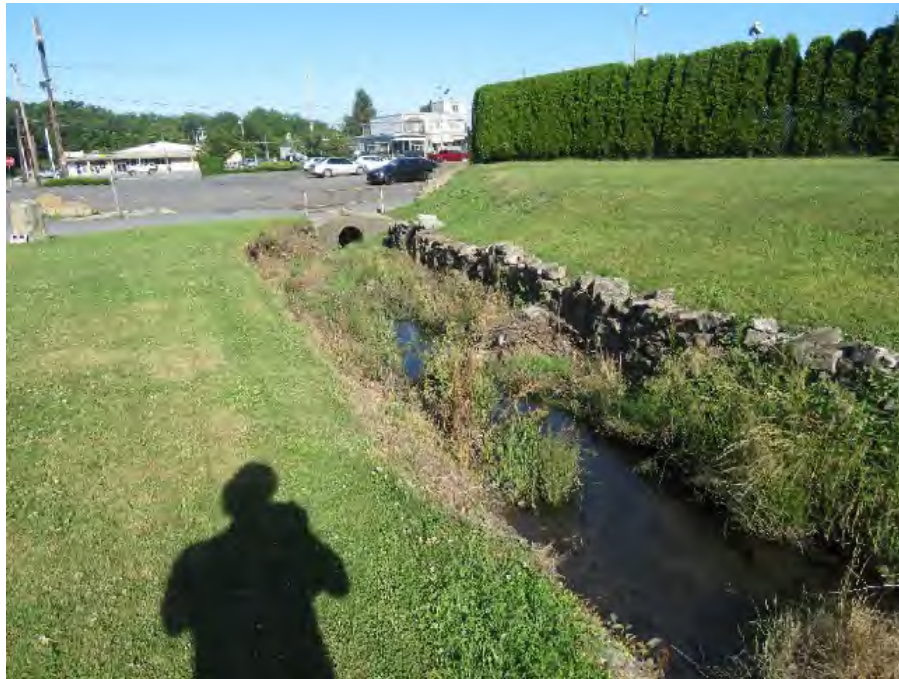
Impacted Stream Segment #7-11:

This stream segment includes a failed stream enclosure. The stream enclosure, originally consisting of an underground pipe, requires removal. In the upstream portion of this stream segment, the channel is eroded. The stream flows under a road through a double culvert pipe, which is now partially blocked. Downstream of the stream enclosure, the banks are 3-4' high and actively eroding.

The restoration of this area includes installation of a stream enclosure by the municipality. The project is funded and was under construction during the streamwalk. The installation of this project

was not included in the preliminary probable cost opinion. The project may serve as matching funds for future projects depending on the funding source. Future improvements to this area could include installation of bioretention areas and stormwater retrofits, such as under pavement inlet filtration and storage systems.

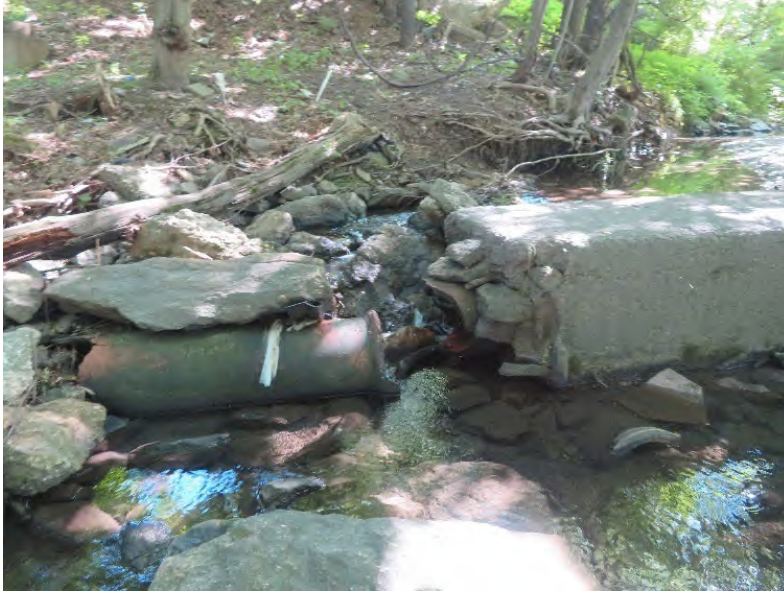
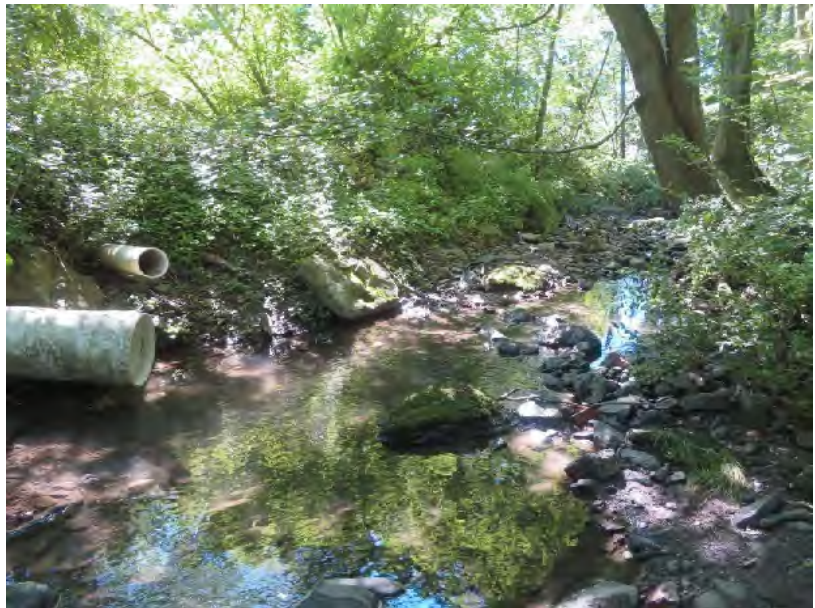
Impacted Stream Segment #22-24:

This stream segment is directly downstream of a Natural Resources Conservation Service (NRCS) riprap project. Banks are heavily eroding and as steep as 6' high in parts of this stream segment. There is a concrete encased abandoned sewer line obstructing the stream in this segment. There is an existing manhole adjacent to the stream, and streambanks are eroded 3-4' high near the obstruction. Several stormwater drainage pipes discharge into this segment of the stream.

Restoration of this stream section should target work within the channel to stabilize the actively eroding streambanks. The old sewer line should be removed from the stream channel. Floodplain restoration is required on the northern bank of this section of stream. Downstream, the south side of the stream has a connected floodplain and the streambanks are stable.

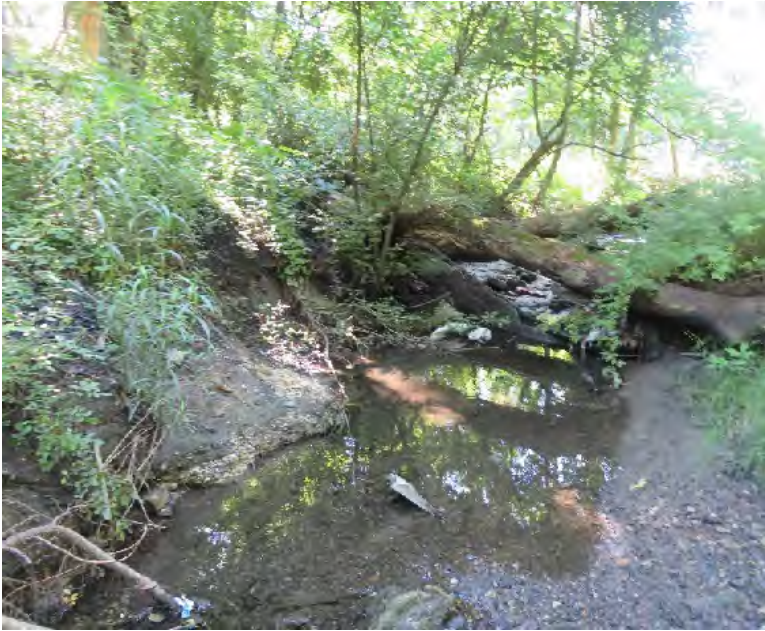
Impacted Stream Segment #16-17:

Within this stream section, the streambanks are actively eroding. Currently, the streambanks are eroded approximately 4' high. The floodplain is disconnected from this stretch of stream. This section of stream is located between two stream crossings. Within the residential area just downstream, citizens are at an increased risk of flooding due to lack of floodplain connection and wetland areas.

Within this portion of the watershed, restoration efforts should target the stabilization of the actively eroding streambanks. Reconnection to the floodplain will mitigate the risk of flooding in this area and downstream. Wetland construction within the restored floodplain will aid in retaining floodwaters, filter pollutants, and improve wildlife habitat. Downstream of this section, the floodplain is connected to the stream and the streambanks are stable.

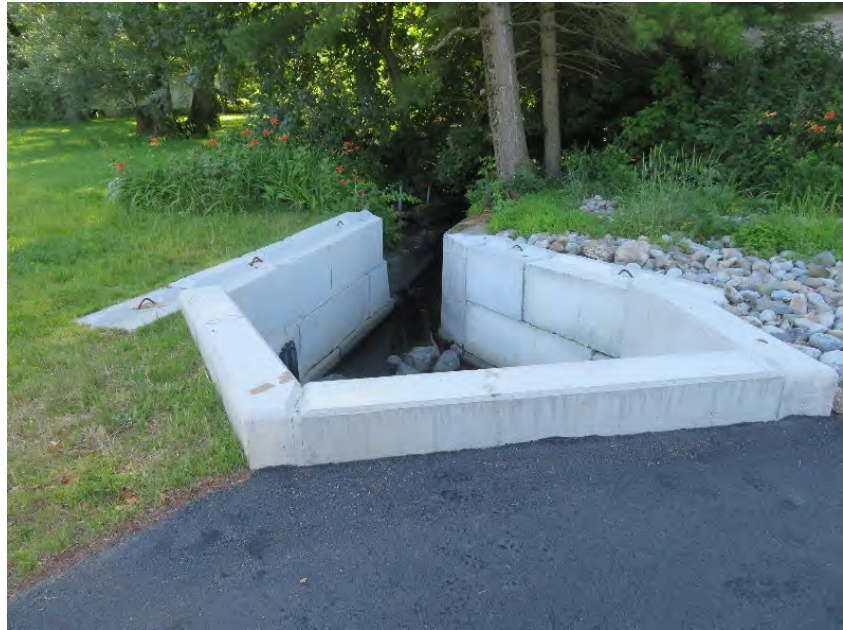
Impacted Stream Segment #20:

This area consists of a recently constructed stormwater inlet. The upstream end of the inlet (see picture below) is composed of concrete blocks which constrict the channel. The constriction of the channel in the upstream end is problematic because the shape of the inlet makes the structure more prone to blockage by debris during storm events. When the channel is blocked, flooding conditions may be exacerbated and the downstream properties and homes are likely to be flooded.

Because of the topographical conditions of the property directly upstream of the stormwater inlet, creation of a constructed wetland upstream would be feasible. The creation of a wetland would work to mitigate flooding downstream, while working with the current confines of the existing stormwater inlet. If the property owner is amenable to the project, a constructed wetland to the east of the stream, just upstream of the reconfigured stormwater inlet could be created.

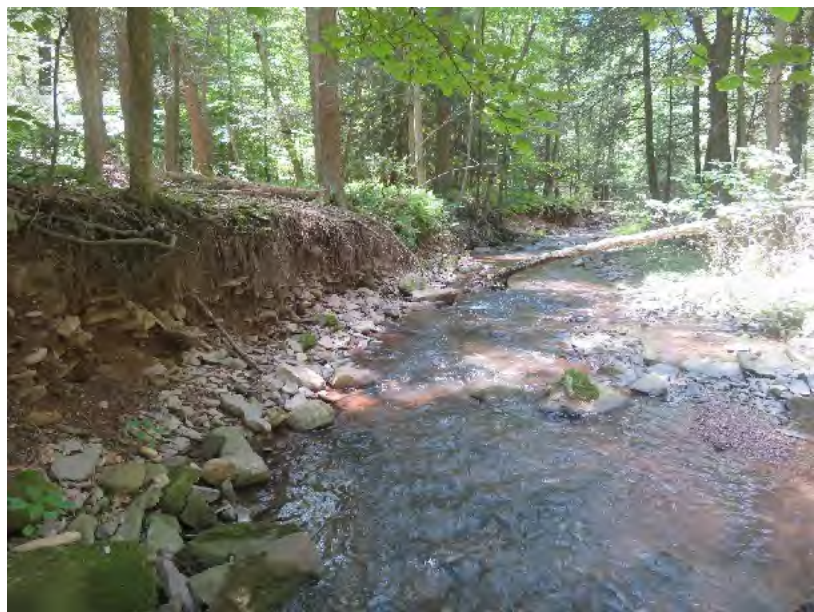
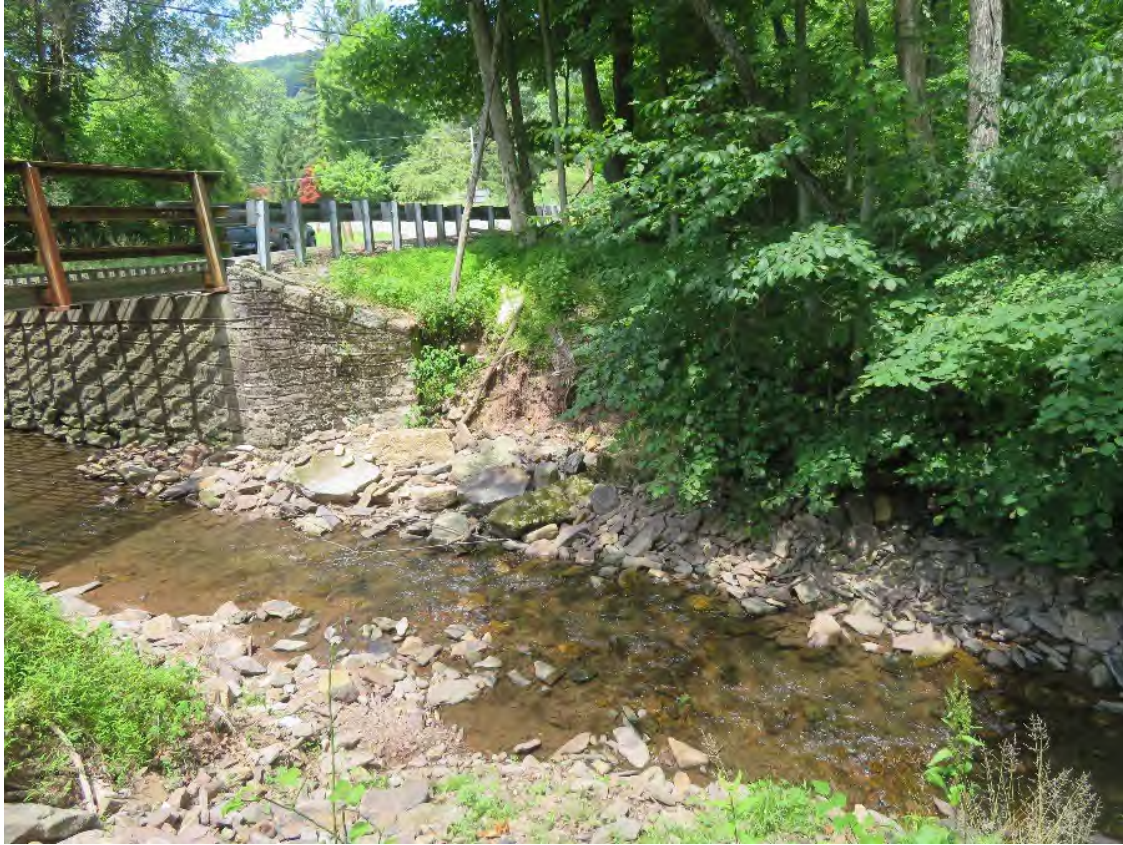
Impacted Stream Segment #47-50:

Within the upstream portion of this stream segment, the southern banks are actively eroding, and are currently eroded 6-10 feet high. Downstream, the stream channel is incised, and eroded 4-10 ft high upstream of the Malones Road Bridge. Downstream of the bridge, the streambanks are stable.

Streambank restoration should be utilized to enhance and protect the stream. The streambanks should be pulled back and stabilized with native vegetation. The use of natural stream design techniques that appropriately incorporate log and rock habitat enhancement structures such as vanes, root wads, j-hooks, and mud sills should be considered.

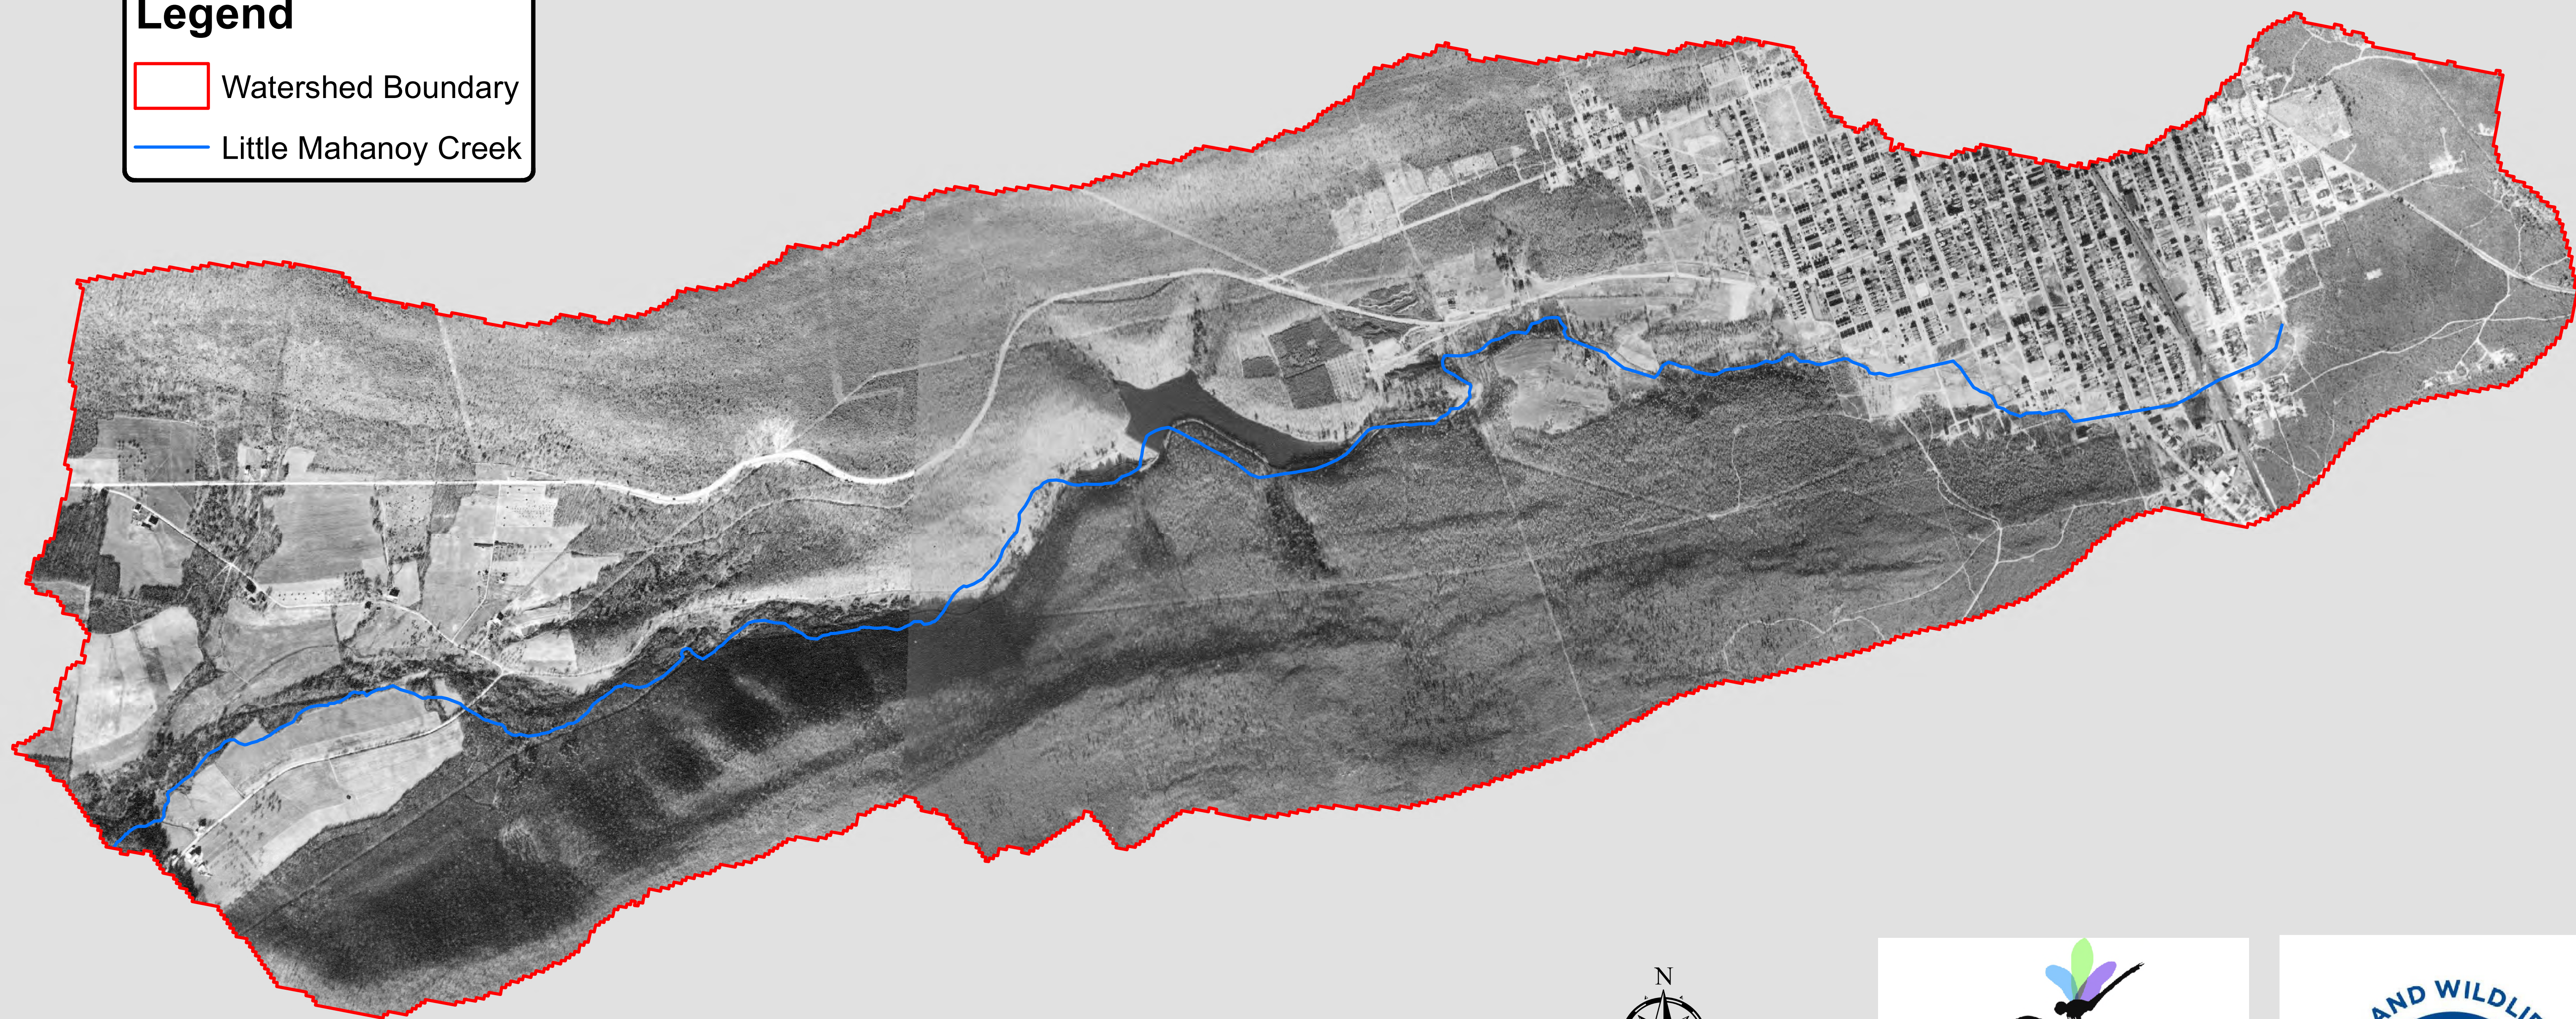
1938 Aerial Photography

Data Sources:
US Agricultural Adjustment Administration
Aerial Photos Taken: November 20, 1938
Schuylkill County GIS Department
Clauser Environmental, LLC
PennPilot

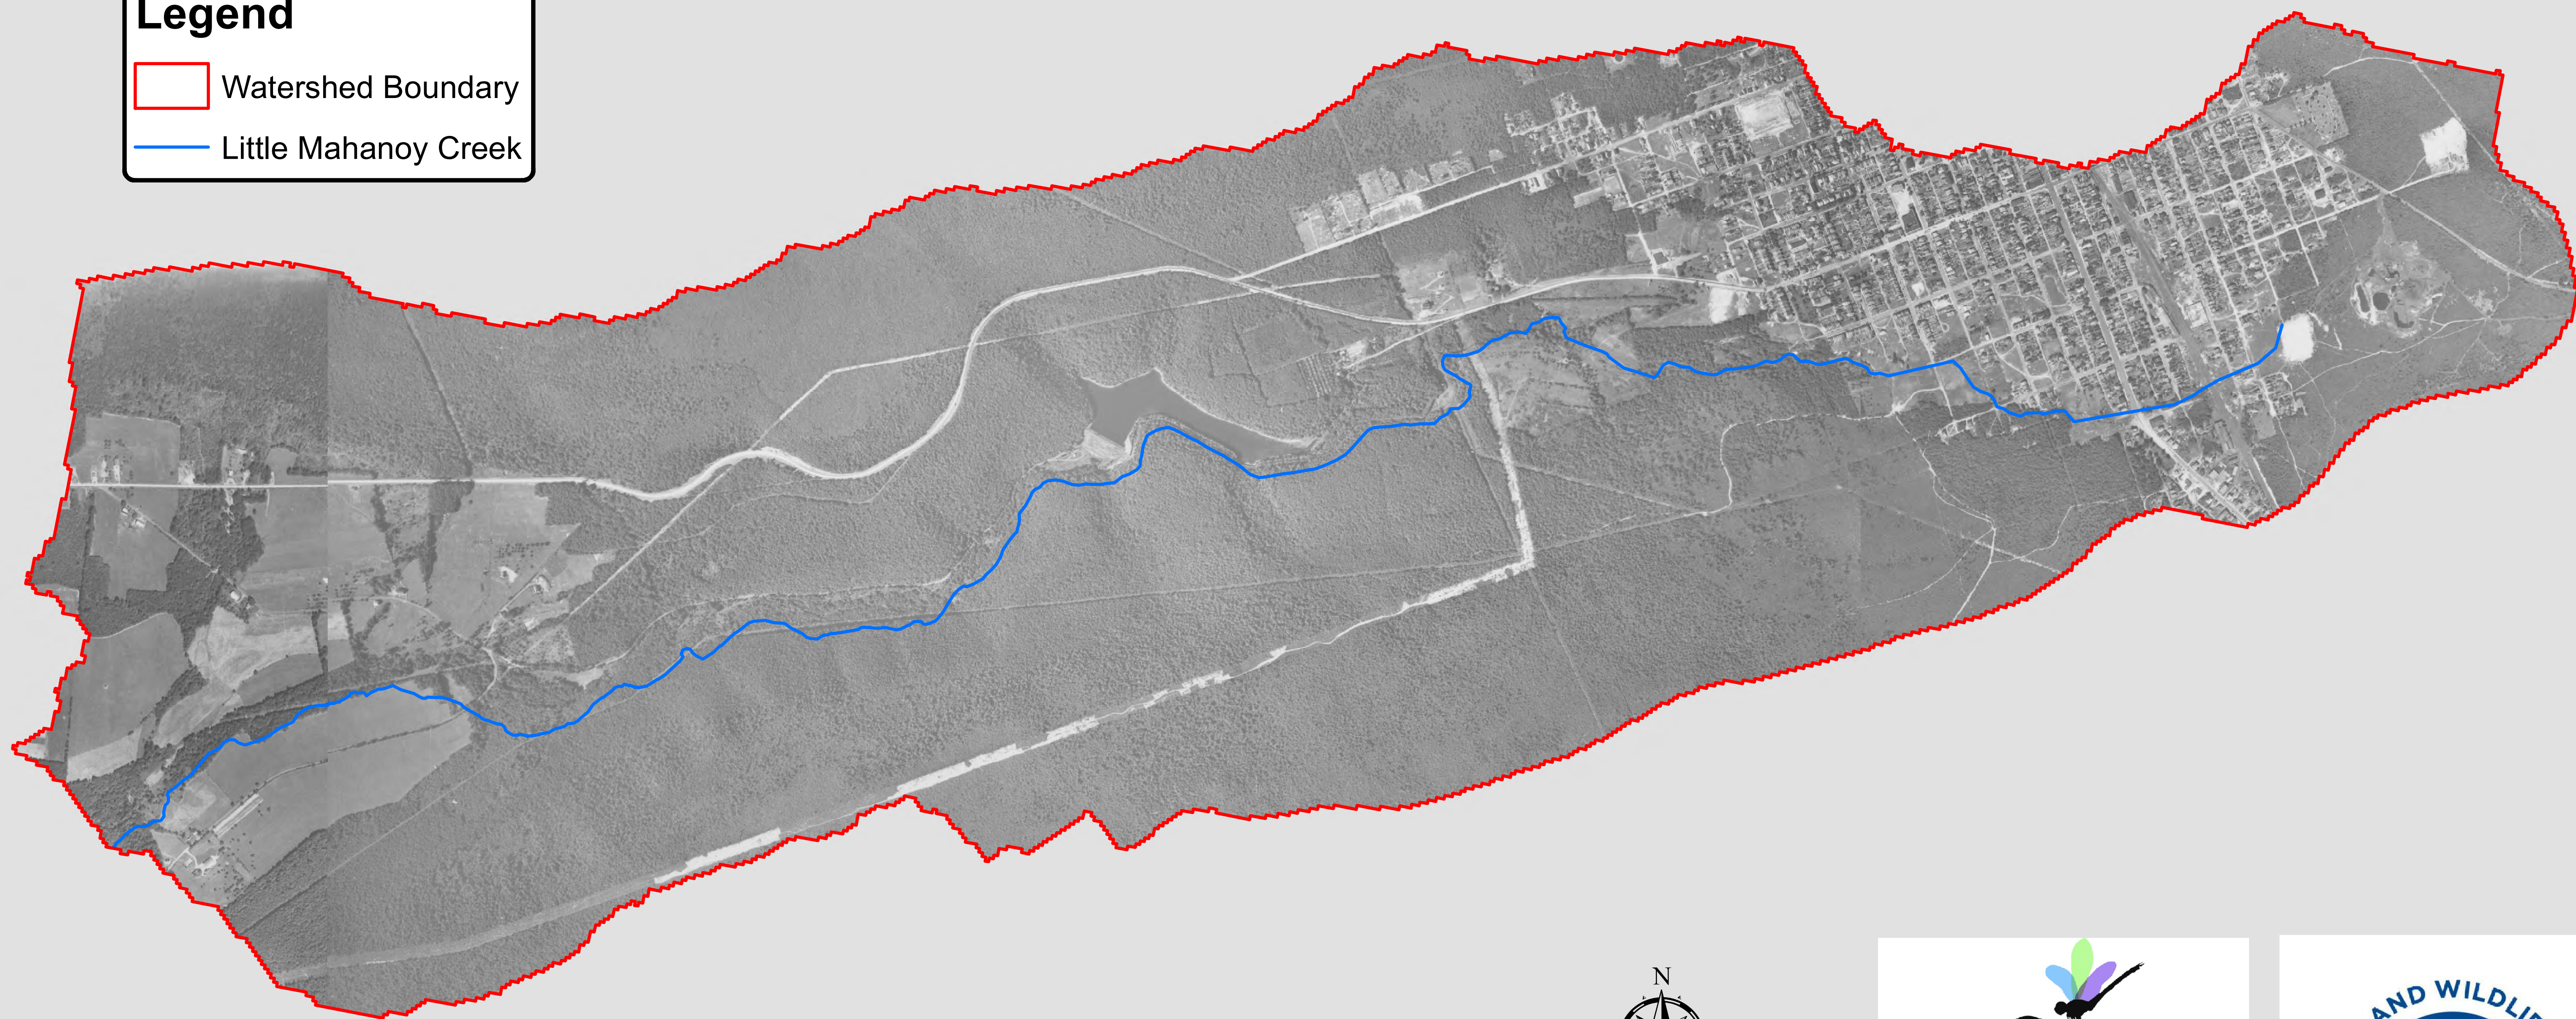
1947 Aerial Photography

Data Sources:
US Agricultural Adjustment Administration
Aerial Photos Taken: September 17, 1947
Schuylkill County GIS Department
Clauser Environmental, LLC
PennPilot

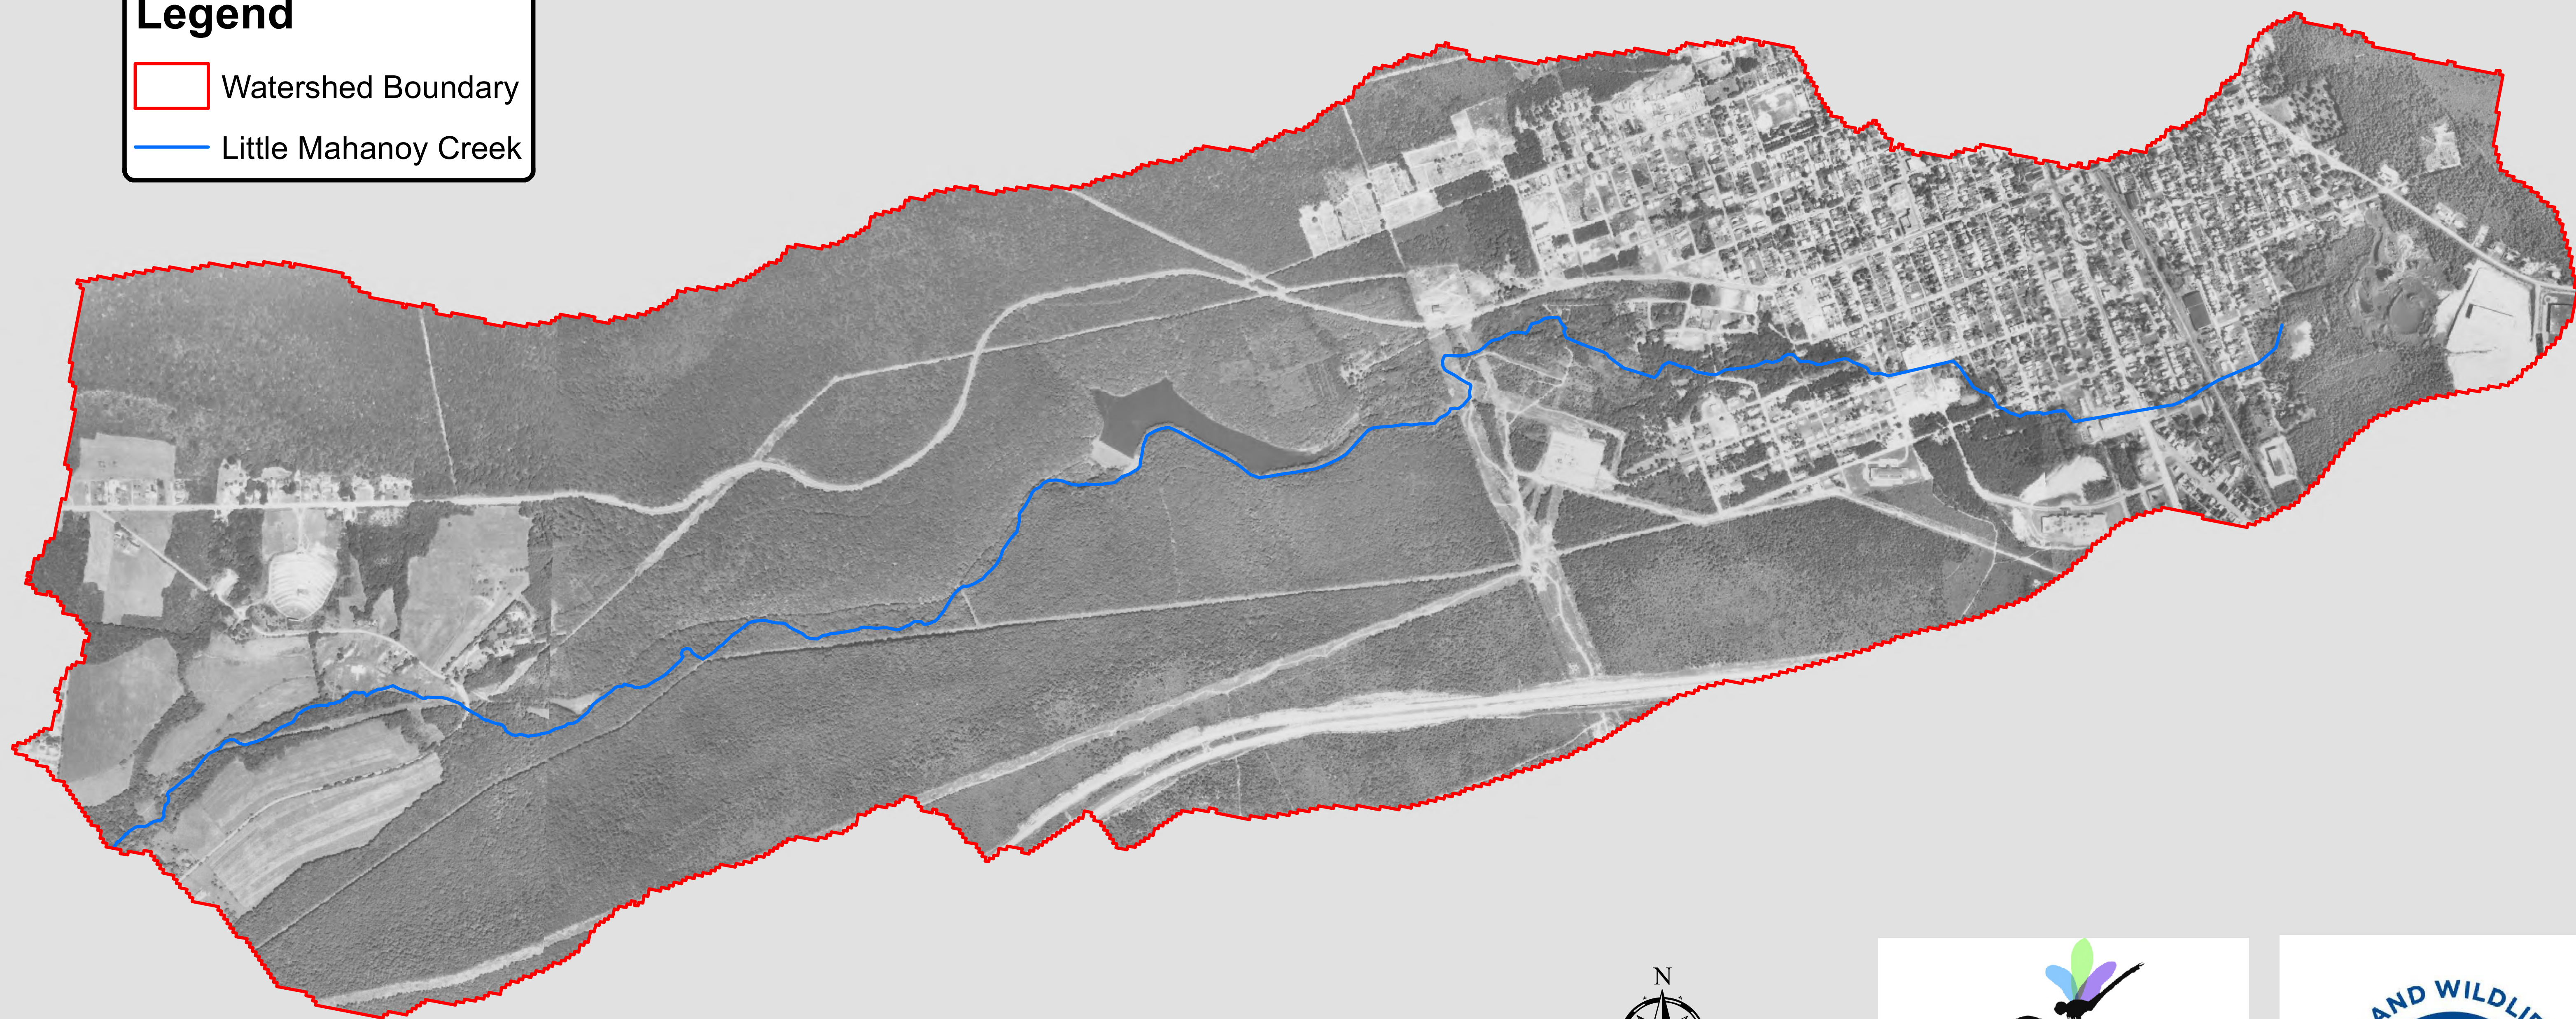
1971 Aerial Photography

Data Sources:
US Agricultural Adjustment Administration
Aerial Photos Taken: August 12, 1971
Schuylkill County GIS Department
Clauser Environmental, LLC
PennPilot

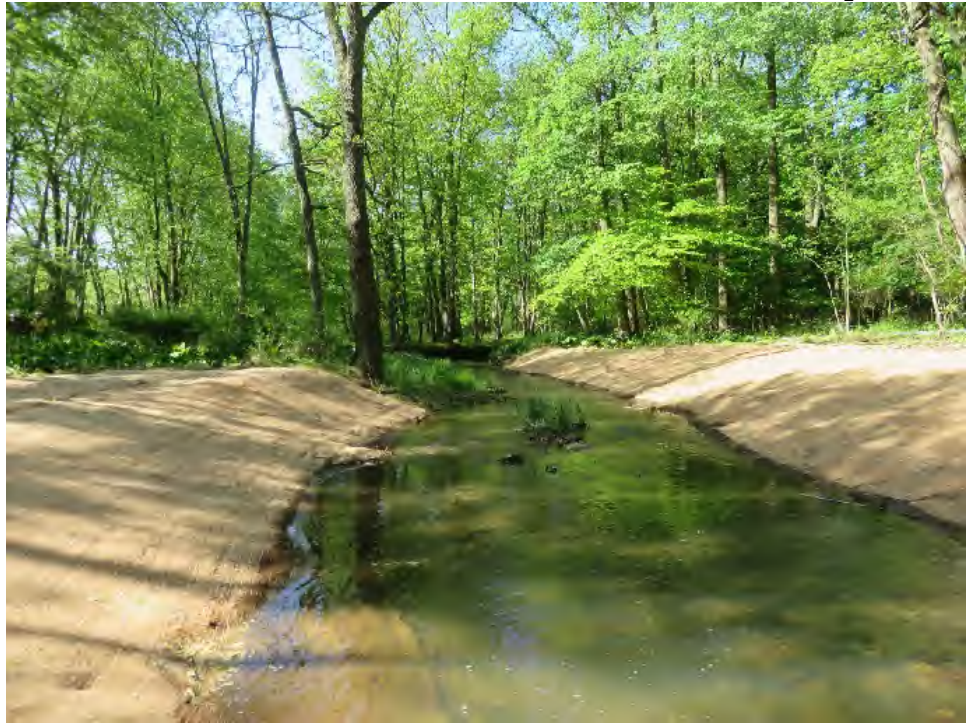
Where streambanks are actively eroding, stabilization that focuses on establishing native vegetation is often the best

long-term option. As the vegetation becomes established, a combination of rip-rap and vegetation are often implemented to provide stabilization. The use of well positioned in-stream deflectors, cross-vanes, j-hooks, and straight vanes can help to hold the streambanks in place as the vegetation becomes established. These structures, when utilized effectively, minimize streambank erosion by reducing the force of water that is scouring the bank surface and provide habitat for many types of aquatic life.

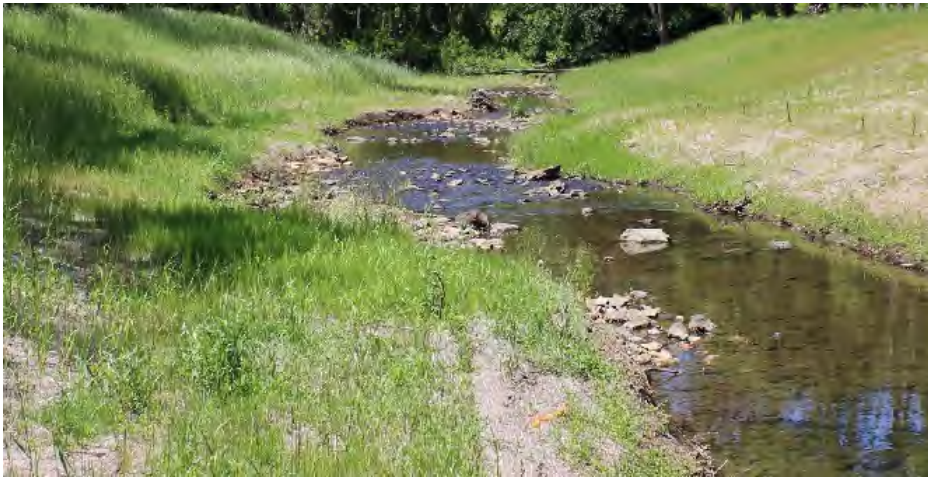
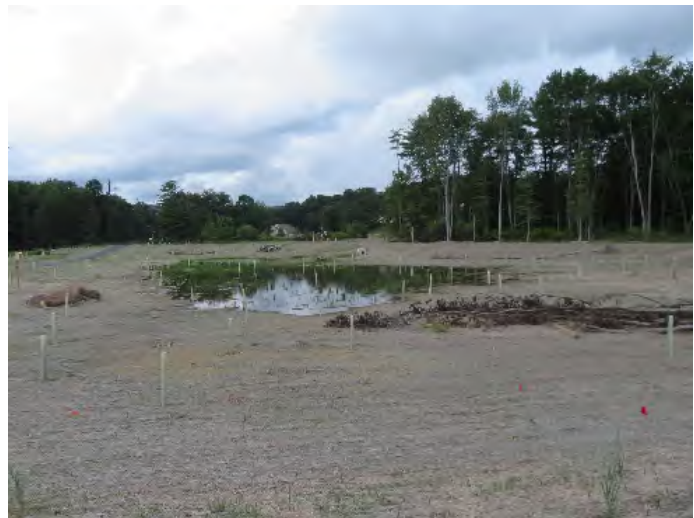
Floodplain Restoration

In many areas of the Little Mahanoy Creek Watershed, past human activities have placed fill in or caused extensive sedimentation within the riparian zone. The excess material along the edge of the stream channel has disconnected the

stream from the floodplain. Floodplain restoration projects are designed to remove excess soil from the floodplain so that the stream is reconnected to an active floodplain. Active floodplains are important to not only reduce the volume and velocity of floodwaters, but also to filter nutrients and pollutants from floodwaters and to provide habitat for a diverse riparian community. The restored streambanks and floodplain area can be planted with native wildflowers, grasses, shrubs, and trees to help stabilize the riparian zone and promote use of the area by a diversity of native wildlife. Floodplain restoration projects can range from establishing a small bankfull bench to help disperse flows to large scale excavation projects that uncover the historic valley floor.

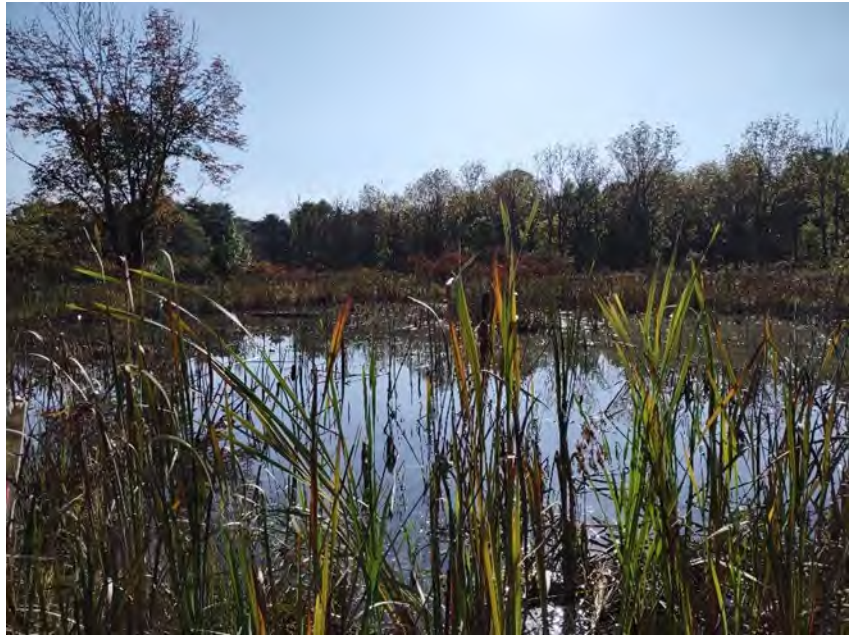
Constructed Wetlands

Many areas within the Little Mahanoy Creek Watershed lack connections to wetlands, specifically in the top portion of the watershed in Frackville, PA. Creation of constructed wetlands in the watershed will have multiple positive impacts on the watershed. Foremost, constructed wetlands can serve to remove contaminants and pollutants caused by human activity from the water supply through the same processes of naturally occurring wetlands. These processes help to remove and break down contaminants. Constructed wetlands not only offer the benefit of water quality improvements through a natural and holistic process, but also provide a variety of niche habitats for local plants and wildlife. Wetlands are considered to be one of the most productive ecosystems on Earth, and provide habitat for birds, mammals, amphibians, reptiles, as well as diverse plants and fungi in the area. Constructed wetlands can help to reduce the impacts caused by erosion as complex root systems of wetland species helps to anchor soils. Additionally, wetlands can mitigate the impacts of flooding and aid in groundwater recharge. This phenomenon occurs because of the ability of wetlands to hold significant amounts of water, which otherwise might pose a threat to urban areas nearby and downstream.

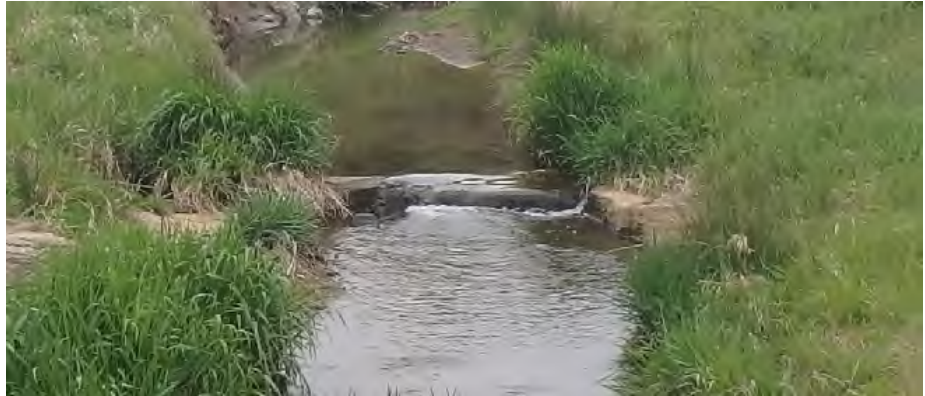
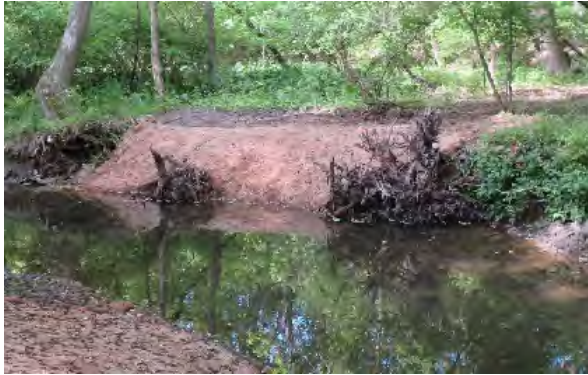
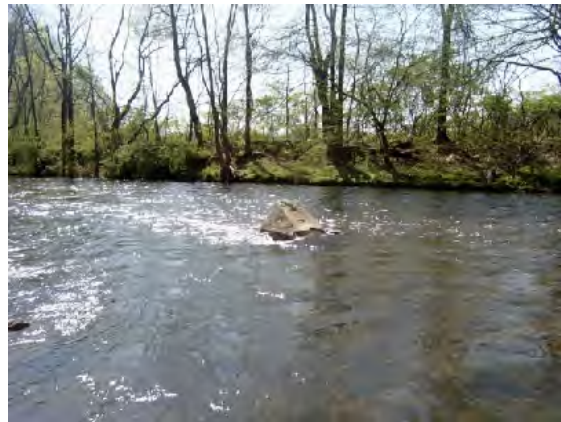
In-stream Restoration Structures

In-stream rock and log deflectors, cross-vanes, j-hooks, and boulder placements are effective tools for creating in-stream fish habitat and aiding in the stabilization of streambanks. The structures are typically constructed based on what materials are available on the site or are locally available. Root wads from clearing operations may be

flows or aligned to roll the stream flow away from the bank and into the center of the channel. In-stream structures are typically designed to manage low to moderate flow conditions and help shape and maintain a natural stream configuration. During high flow events, the structures are designed to stay in place beneath the floodwaters.

Root wads from clearing operations may be anchored into the streambanks to slow the flow of water in the stream and create habitat for fish and aquatic life. Log sections may be used to create vanes and deflectors to protect banks and create in-stream habitat. Where needed, boulders can be placed either randomly for fish habitat and to disperse

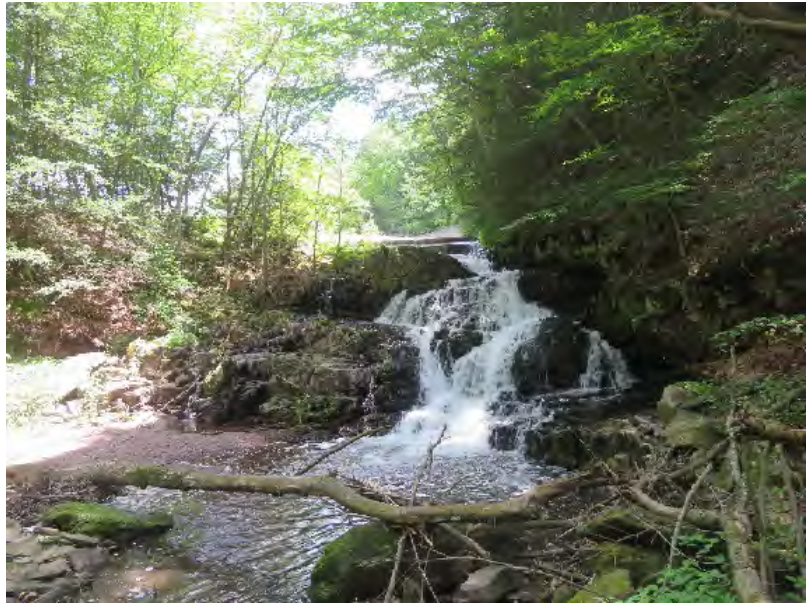
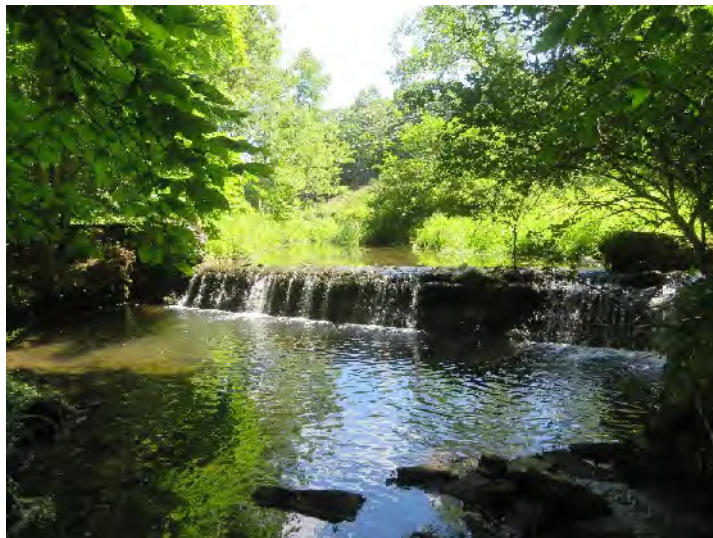
Restore Fish Passage

Alterations to the original course of a stream can result in barriers to fish passage. Barriers include when the velocity of the stream is too high, when jumps fish must make to move through the stream are too high, and when the stream is too shallow for the fish. Fish need to pass through a variety of waterways to reach the ideal conditions to reproduce and feed. At each step of the way, fish balance the nutrient levels within their ecosystems with their waste. If fish are not able

to move between waterways, the entire ecosystems they help to sustain are at risk of failure. Healthy fish populations can help to promote community buy-in to conservation projects. This is because of the value of fish for recreation activities such as fishing and wildlife spotting. There are multiple avenues for restoring fish passage. Some avenues include culvert replacements, installation of rock ramps, dam removal, and by-pass channels.

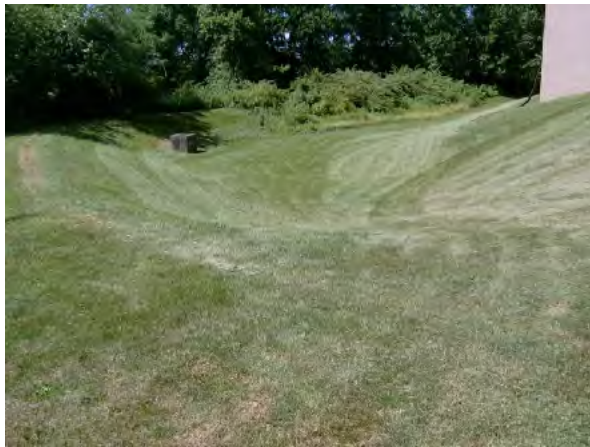
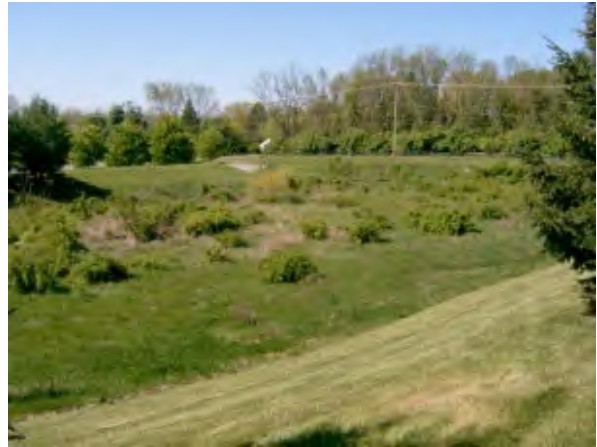
In order to decrease the impacts of stormwater on the watershed, effective best management practices should be installed with new construction. Where existing stormwater structures are present, they should be evaluated for effectiveness and retrofitted where necessary.

Common stormwater retrofits focus on improving the function of existing structures so that they more closely reflect the natural hydrological cycle. Within existing stormwater basins, native species may be planted or allowed to become established. Minimizing mowing and labor in this way provides for additional wildlife habitat, reduces nutrient discharges to the stream, and allows for the vegetation to return more of the stormwater to the atmosphere through evapo-transpiration. Other strategies for stormwater retrofits include installing cisterns to allow for water reuse and infiltration trenches to increase the return of stormwater to the groundwater.
